EXHIBIT E

Case No. 6:24-cv-03183-MDH

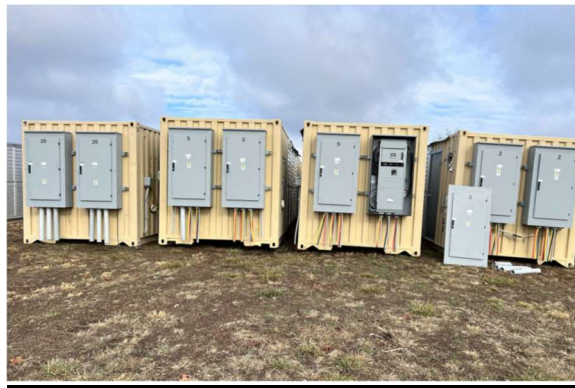
4. There were sixteen containers at the Crocker Site. We could only inspect twelve of the sixteen containers because four of the containers were locked and unable to be opened by Blockquarry personnel. The twelve containers we inspected all had Bitmain Miners based on our review of the model of the machines, which was S19J Pro. The Blockquarry representatives at the site told us that the other four containers also had Bitmain Miners, but we could not confirm this through our inspection. None of the Bitmain Miners we inspected were powered on. The following picture, which we took during the inspection, shows four of the containers we saw at the Crocker Site.

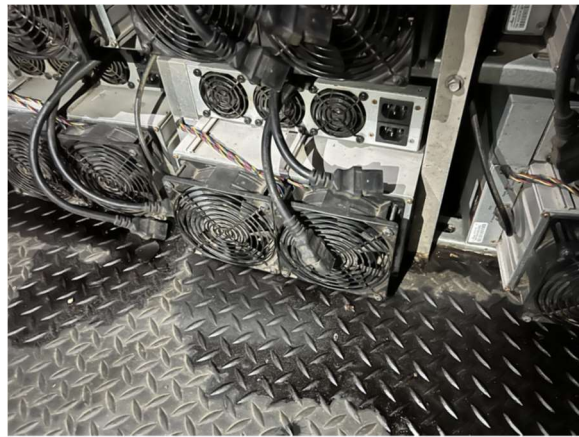
5. We identified water leakage in the containers, which may have caused water damage to the Bitmain Miners that were off-racked and placed on the floor of the containers. The following picture, taken by us during the inspection, shows this water leakage:

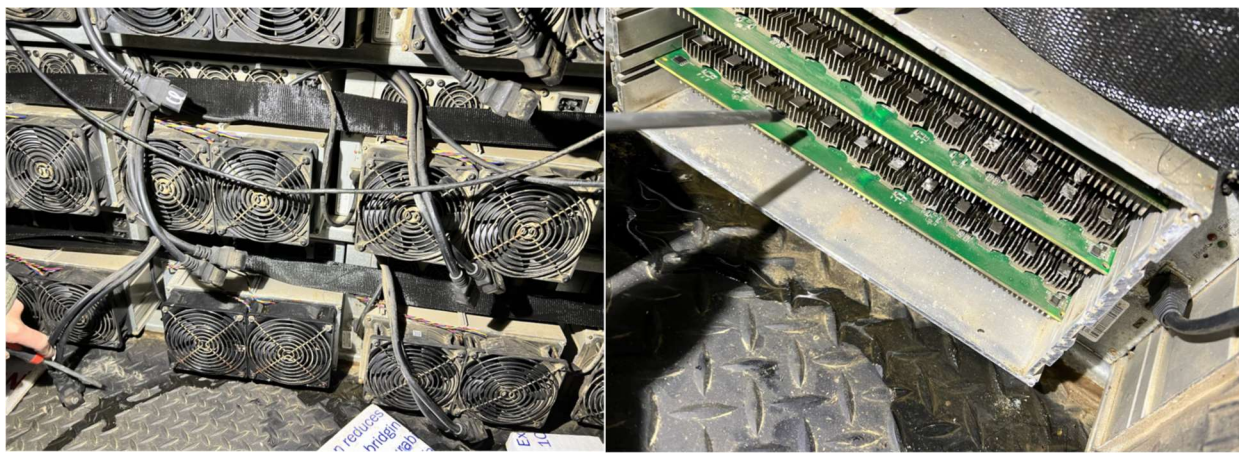
6. We also observed Bitmain Miners with rusted fans and, upon disassembling three such Miners for a more thorough inspection, found that all three Miners had internal rust, including rust on the fans and the hashrate board, a critical component of a mining machine, as shown in the following pictures we took during the inspection:

8. Based upon my initial inspection, I concluded that Bitmain's Miners had been subjected to inadequate environmental controls, including insufficient moisture control and inappropriate temperature settings, which are critical given the Miners' sensitivity to environmental conditions. Generally, the air inlet humidity of the containers needs to be below 65% Relative Humidity and the air inlet temperature needs to be below 30°C. The containers I inspected did not meet these humidity and temperature requirements.

9. If Miners are stored in an overly humid and dusty environment without power, the risk of dust accumulation due to static electricity and corrosion increases, and the inside boards are prone to oxidation.
